REPUBLIC OF LIBERIA
Aircraft Accident Investigation Bureau

PRELIMINARY REPORT

ON SERIOUS INCIDENT INVOLVING RAM BOEING 737-800
AIRCRAFT CN-RGW WHICH OCCURRED AT **ROBERTS**
INTERNATIONAL AIRPORT (GLRB), LIBERIA ON
AUGUST 17, 2024

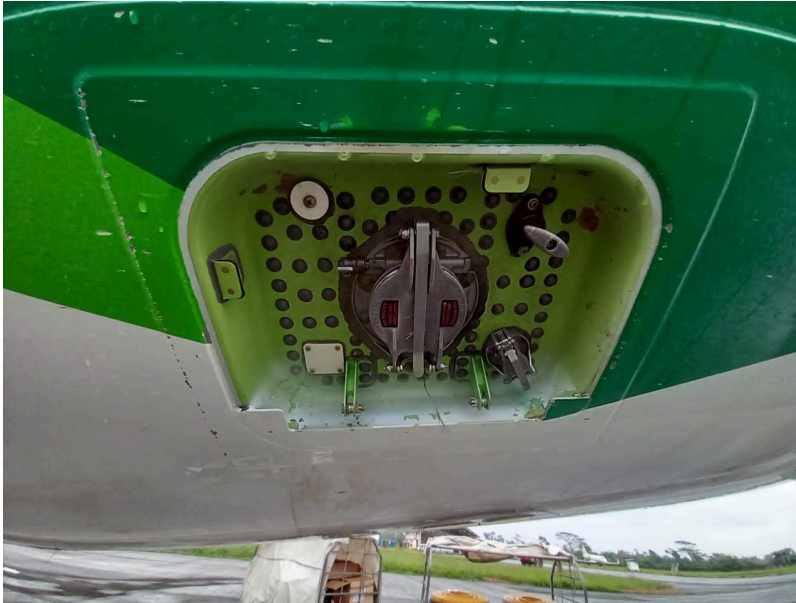
There were six dents on the Left-Hand Fuselage Skin between Stations 787F to 787I, dent with crack on left hand inboard of trailing edge flaps, left hand fuselage emergency lens broken, the lavatory service panel was missing, three dents on the Left-Hand Horizontal Stabilizer Leading Edge Skin, and a crack on the Left-Hand Wing Inboard Aft Flap Lower Skin.

Figure 1: A view of the lavatory compartment with missing panel cover

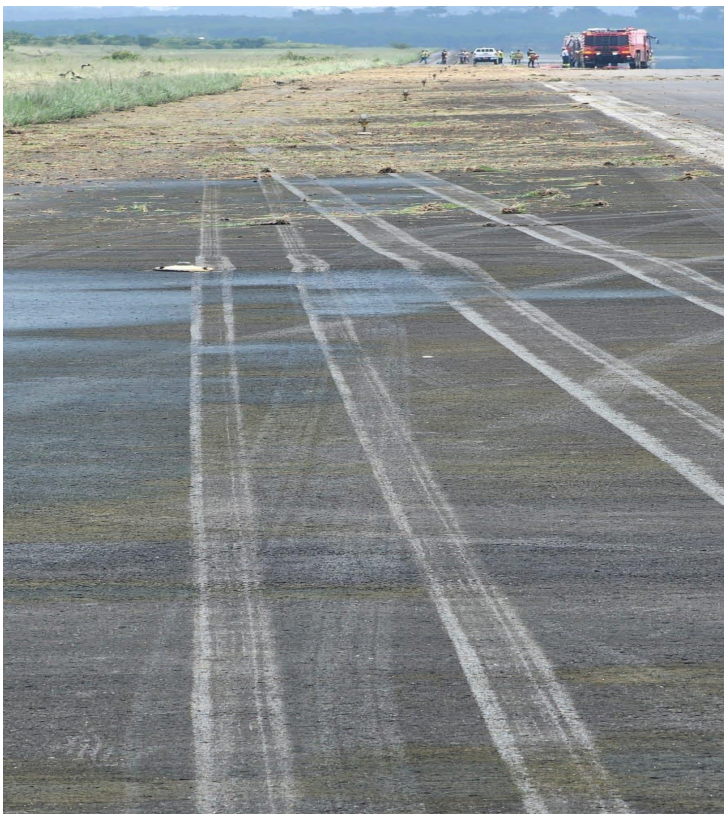
The aircraft touched down on the left side of the centre line on runway 22 within the touchdown zone. On landing rollout the aircraft veered further left until the left main landing gear moved off of the runway and entered into the grass and travelled for approximately 500 feet before returning to the runway. Two runway lights were broken as a result of the excursion. Clear tire marks were observed leaving the runway and creating a rut in the ground adjacent to the runway before returning to the runway.

Figure 2: A view of Runway 04 left shoulder showing the aircraft tire tracks leaving the runway

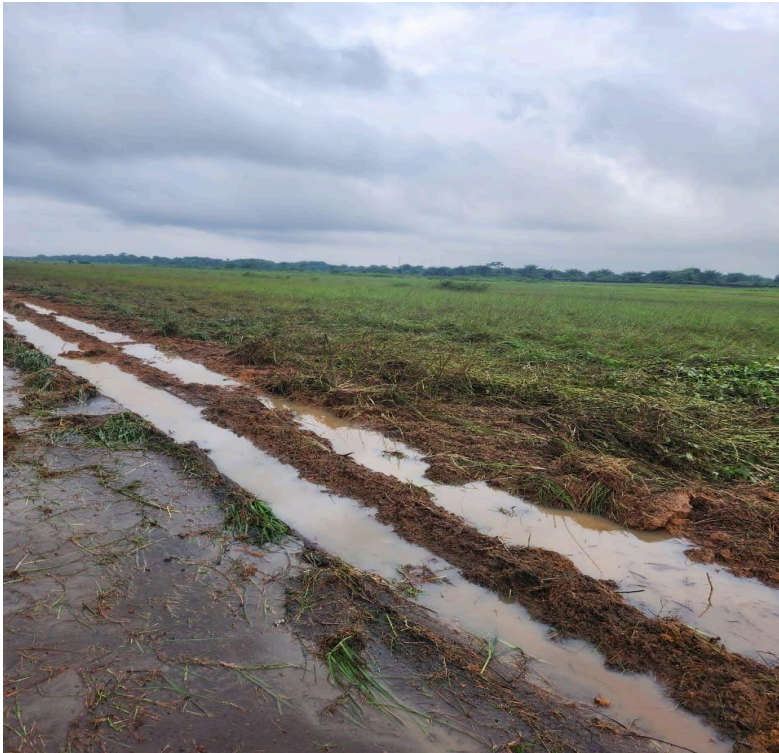
Figure 3: View of rut created by left two tires of the left landing gear on edge of runway 04

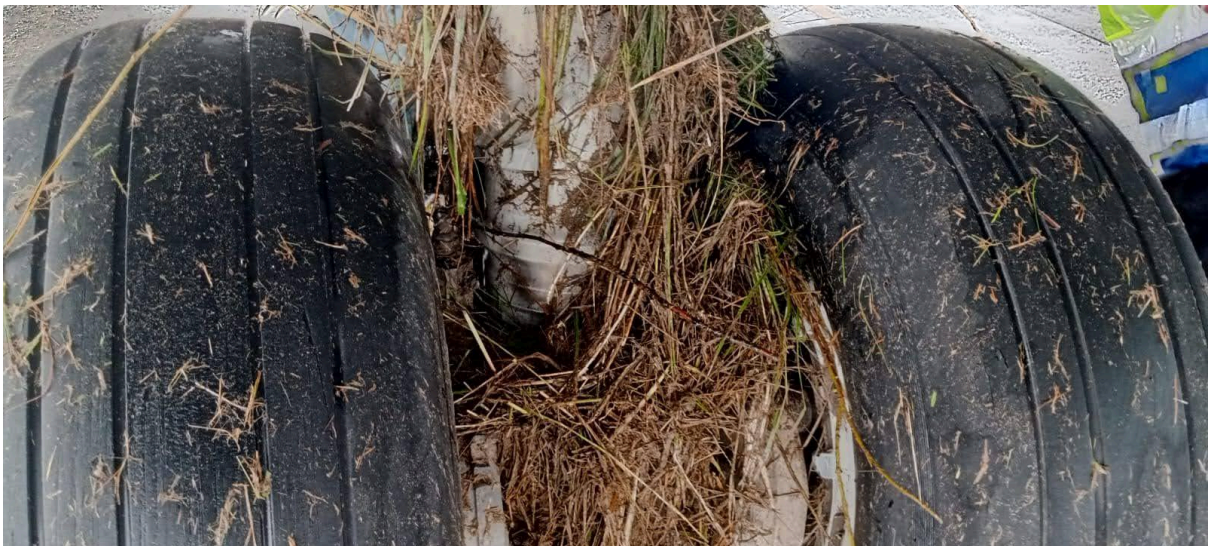
Figure 4: Debris on left landing gear strut

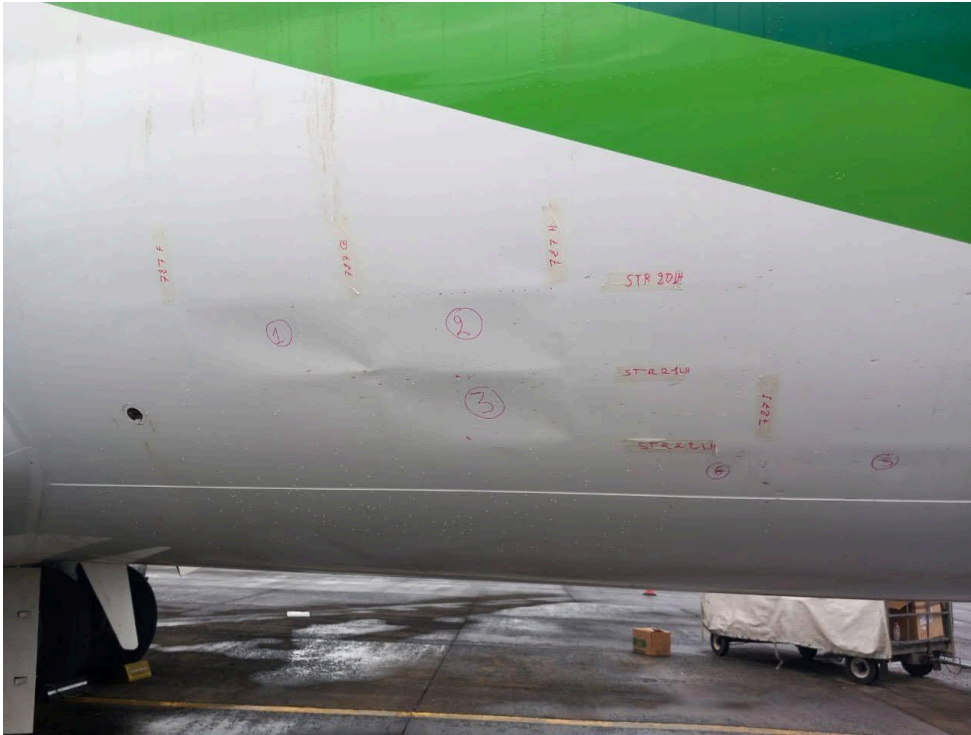
There were six dents on the Left-Hand Fuselage Skin between Stations 787F and 787I, the lavatory service panel door was missing, three dents on the Left-Hand Horizontal Stabilizer Leading Edge Skin, and a crack on the Left-Hand Wing Inboard Aft Flap Lower Skin.

Figure 5: Damage to left side fuselage skin

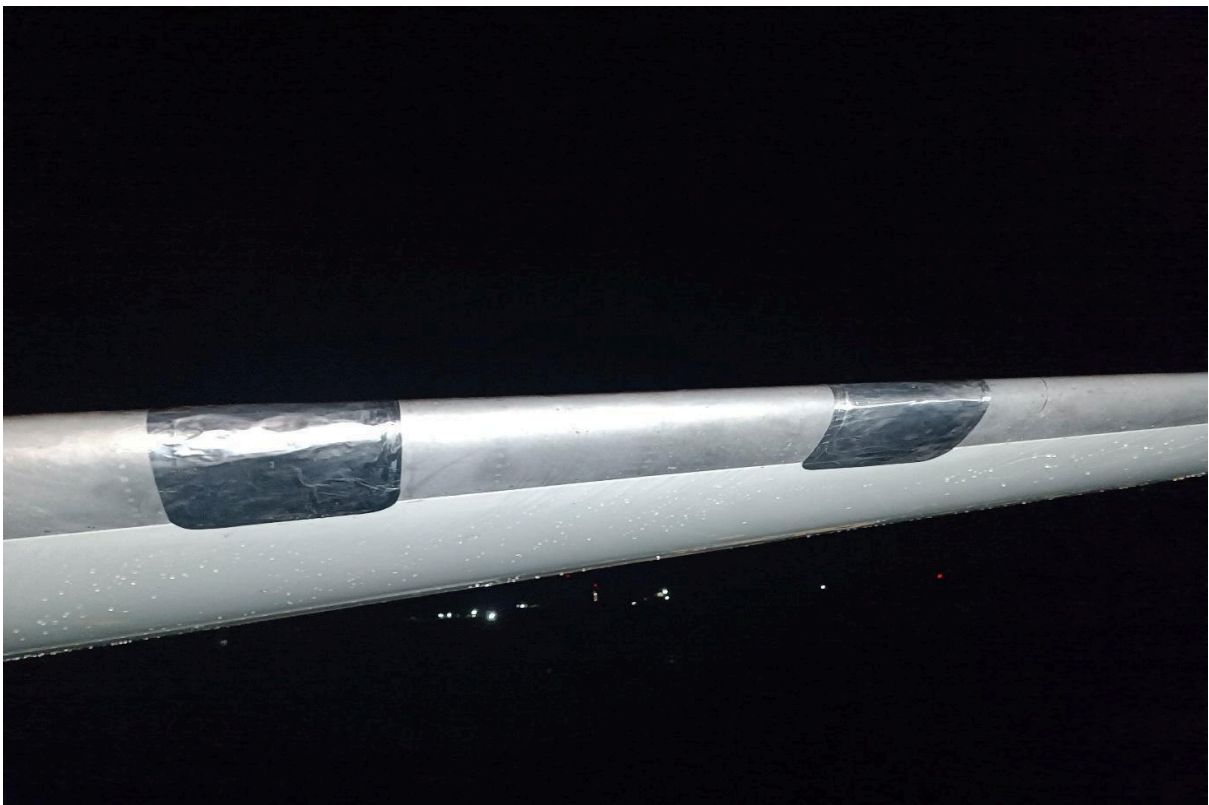
Figure 6: Dent on the left hand horizontal stabilizer leading edge skin with speed tape

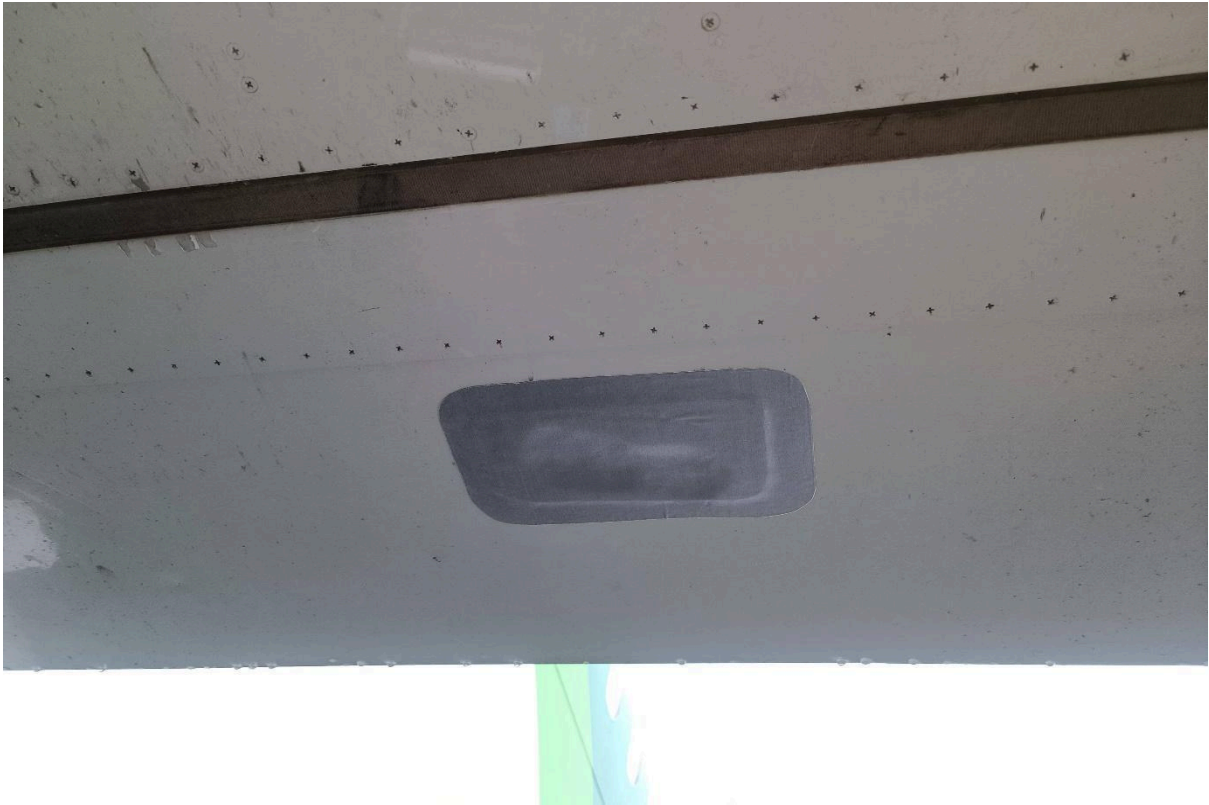
Figure 7: Crack to left hand wing inboard aft flap lower skin covered by speed tape

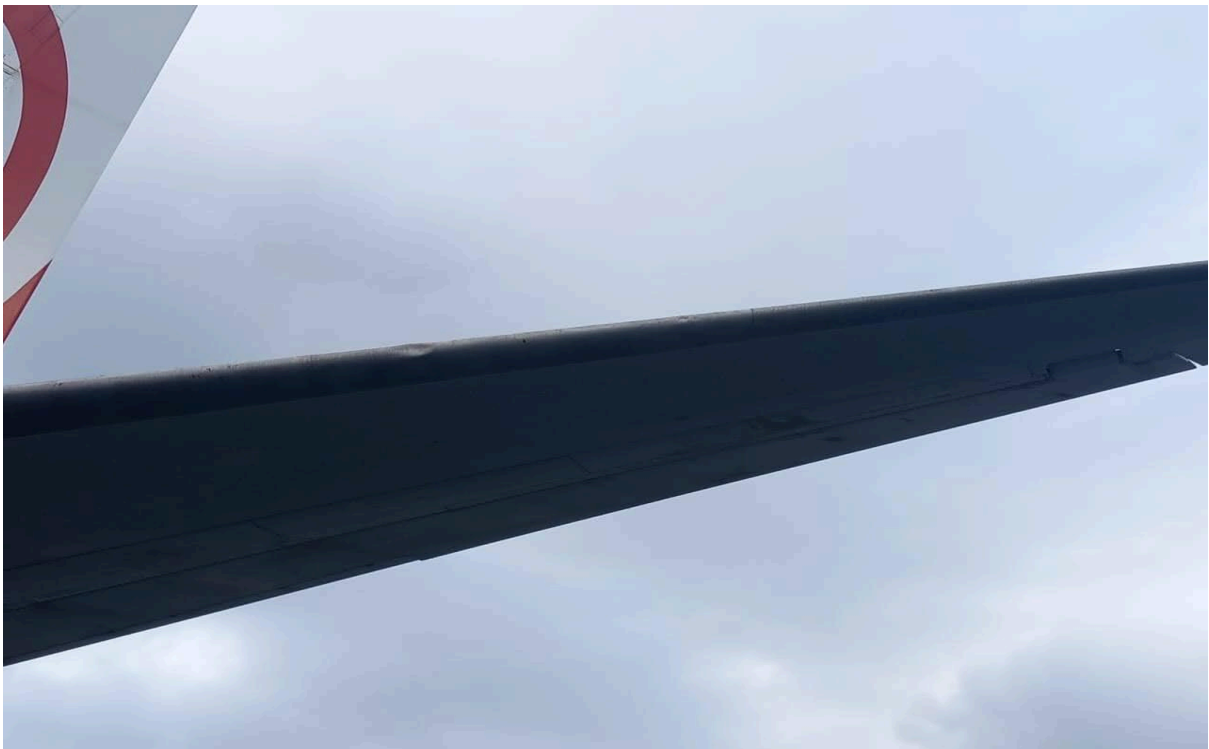
Figure 8: Dent created on the left hand horizontal stabilizer leading edge skin
