REPUBLIC OF LIBERIA
Aircraft Accident Investigation Bureau

FINAL REPORT

RAM/2024/17/09

**ON SERIOUS INCIDENT INVOLVING ROYAL AIR MAROC (RAM)
BOEING 737-800 AIRCRAFT WITH REGISTRATION CN-RGW WHICH
OCCURRED AT **ROBERTS INTERNATIONAL AIRPORT (GLRB)**, LIBERIA,
ON AUGUST 17, 2024**

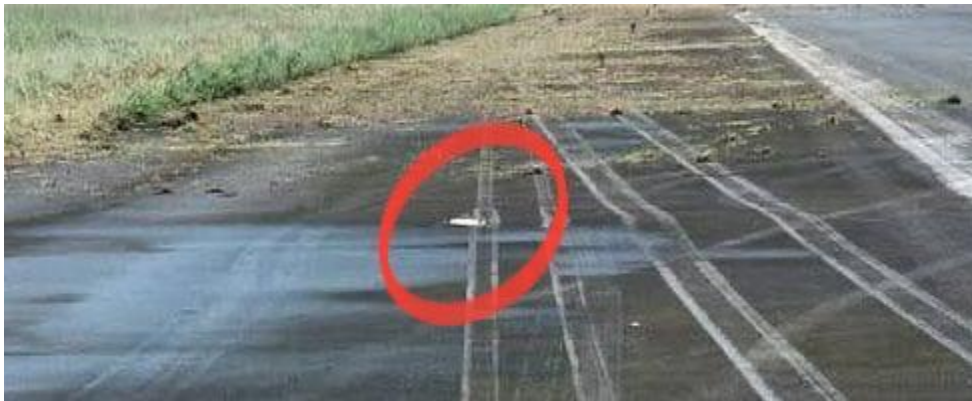
Two broken runway edge lights (L13, L21) and chipping to the runway edges. Two runway lights were broken as a result of the excursion. Clear tire marks were observed leaving the runway and creating a rut in the ground adjacent to the runway before returning to the runway.

Figure 3. Damaged runway edge light L13

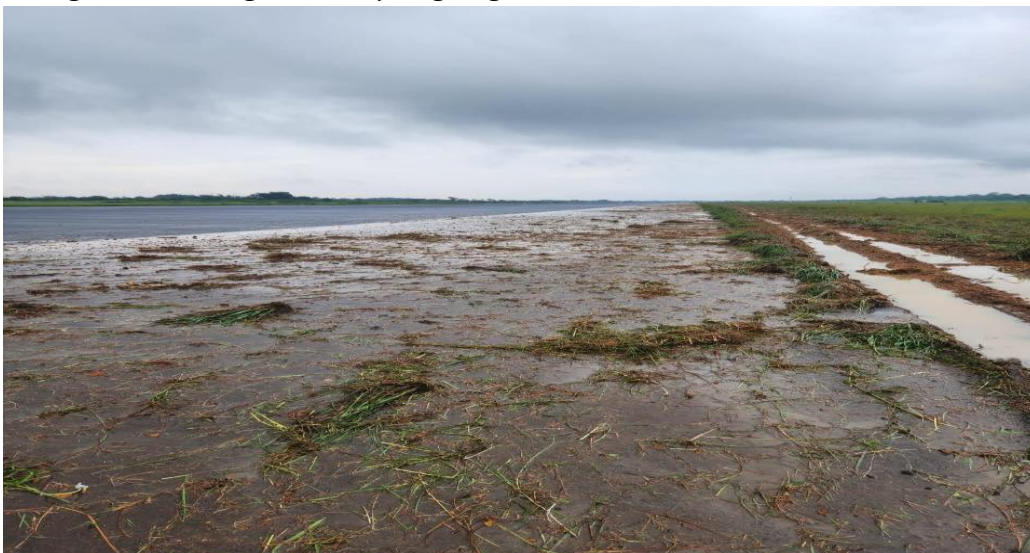
Figure 4. Tire rut along the runway

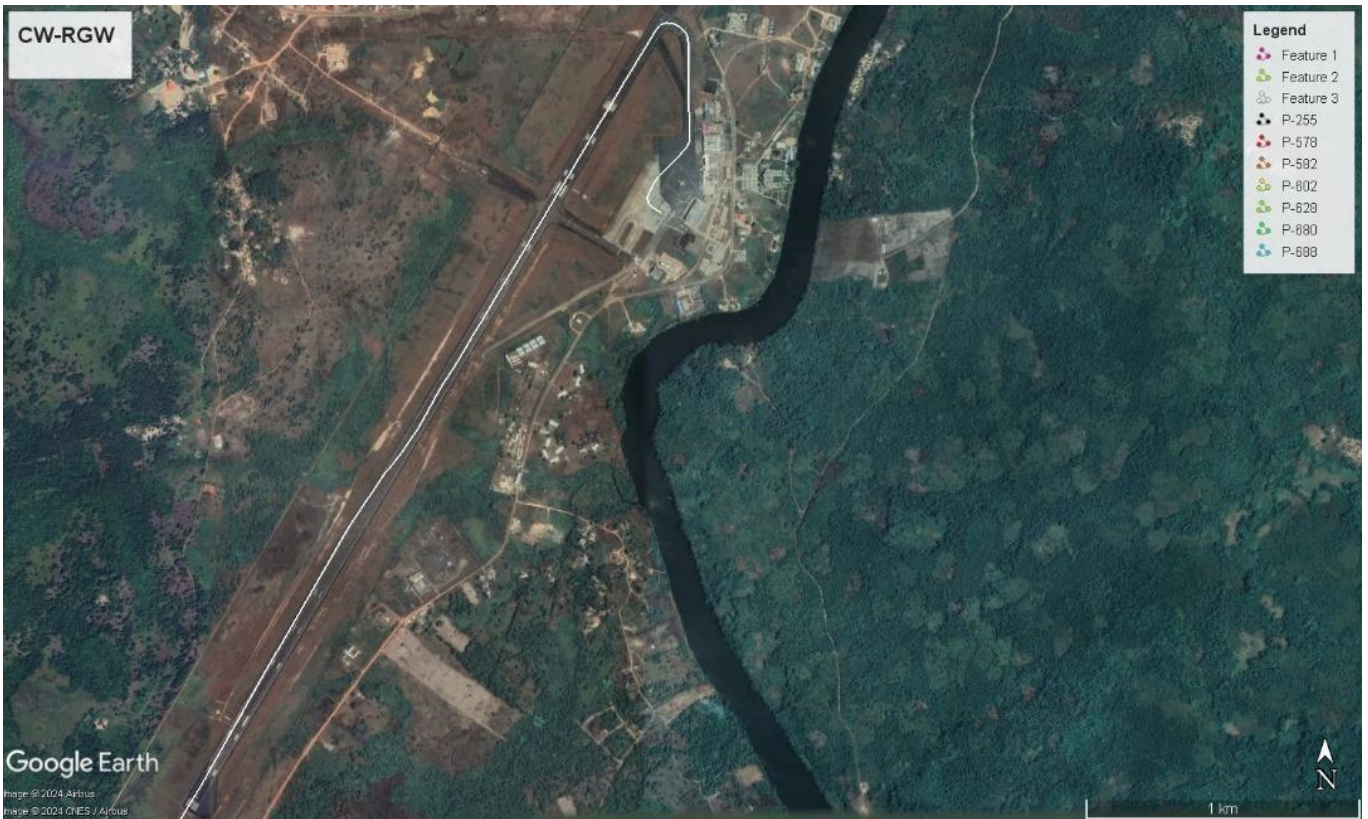
Figure 7. RAM 567 crossing the threshold to the left of the centerline

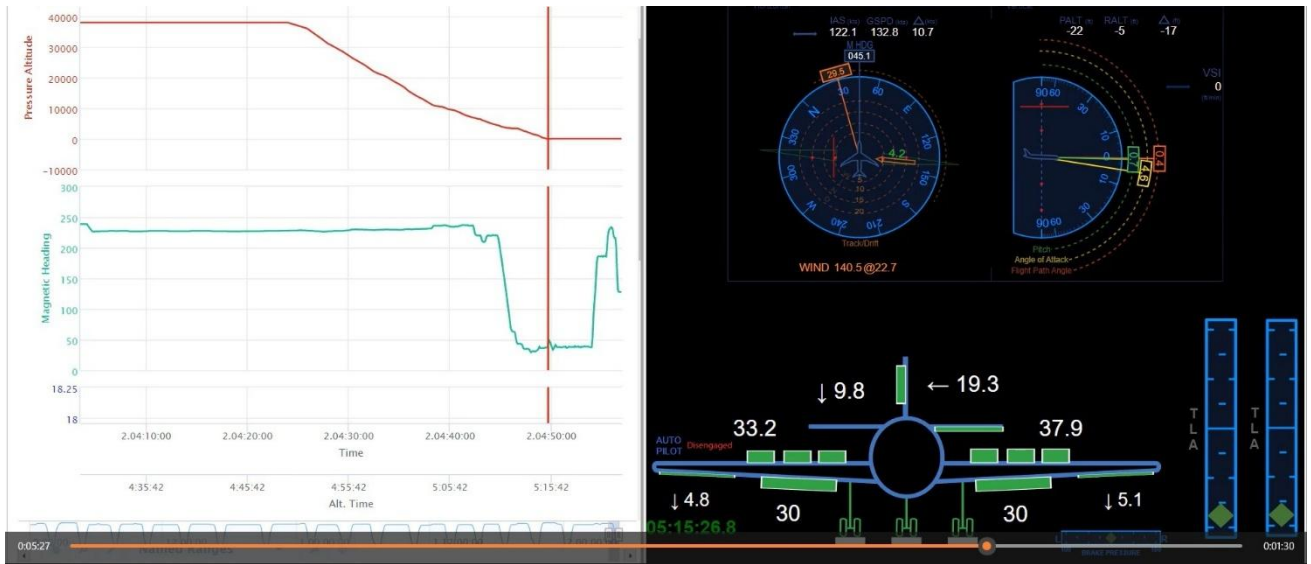
Figure 8. RAM 567 FDR Wind direction and speed upon touchdown

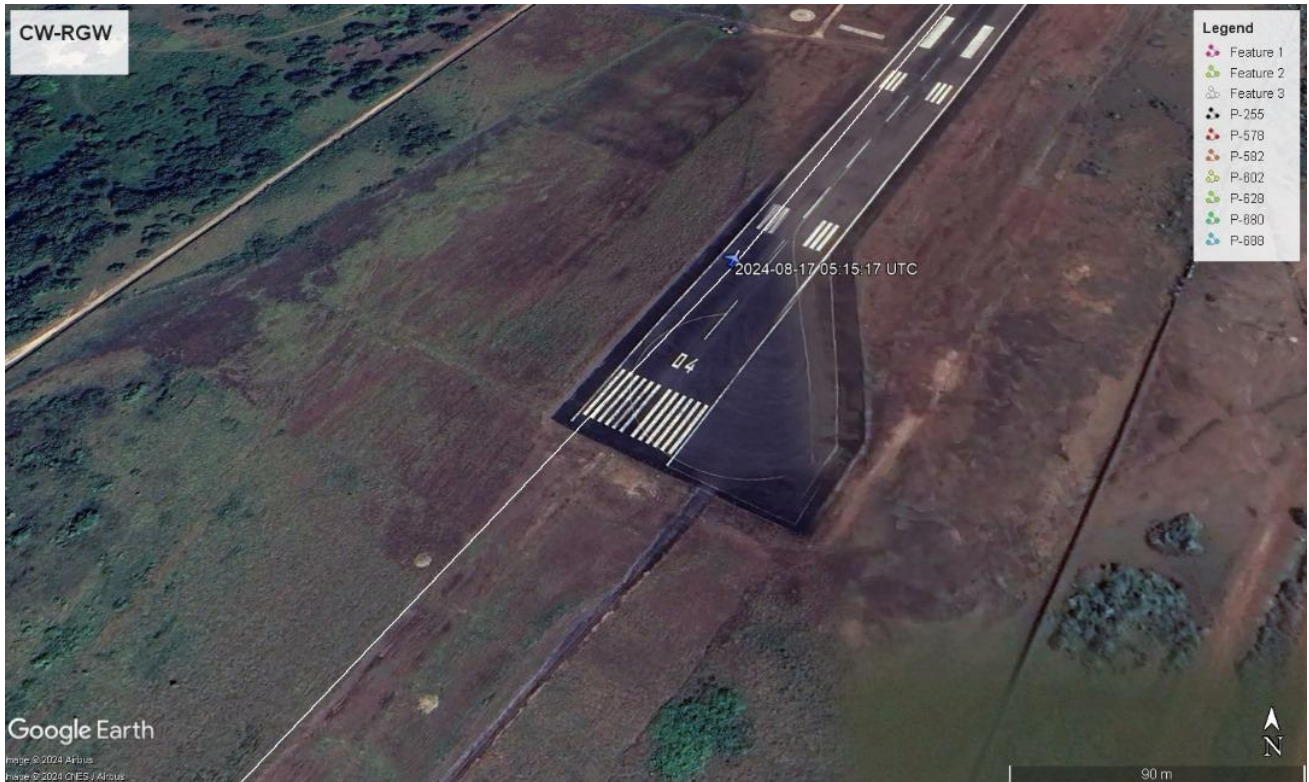
Figure 9. RAM 567 FDR Profile Landing on left of centerline Runway 04 GLRB

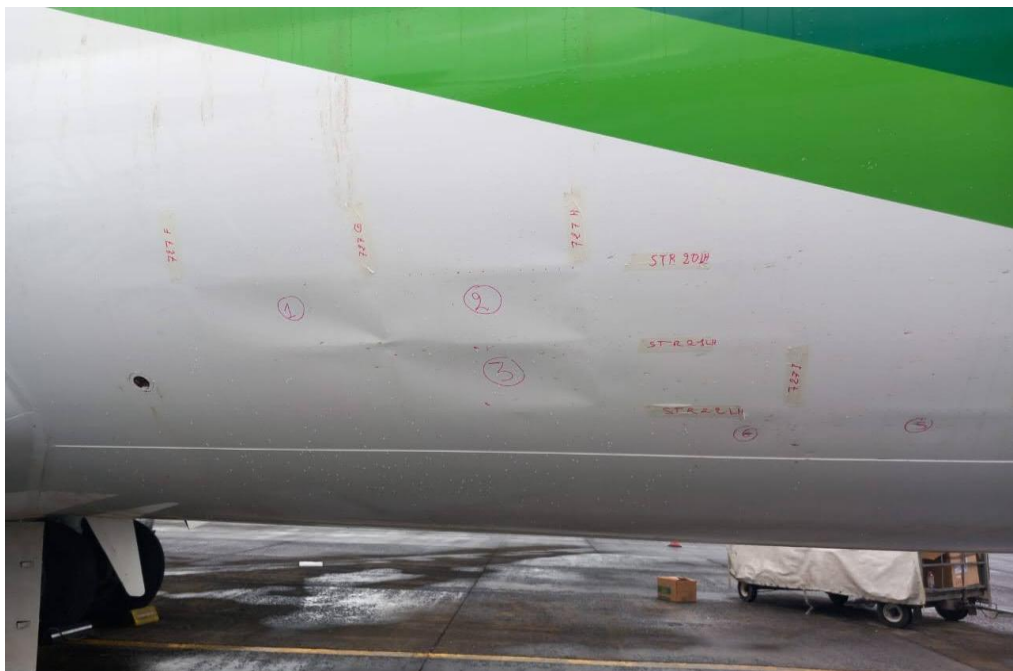
The aircraft touched down on the left side of the Centre line on Runway 22 within the touchdown zone. On landing rollout, the aircraft veered further left until the left main landing gear moved off the runway and entered into the grass and travelled from L14 parallel to the runway and then returned to the runway at around L17. There were six dents on the left-hand fuselage skin between station 787F to 787I, the lavatory service panel cover was missing, the dents on the left hand horizontal stabilizer leading edge skin, and dent with a crack on the left-hand wing inboard AFT flap lower skin.

Figure 10. Damage to left side fuselage skin

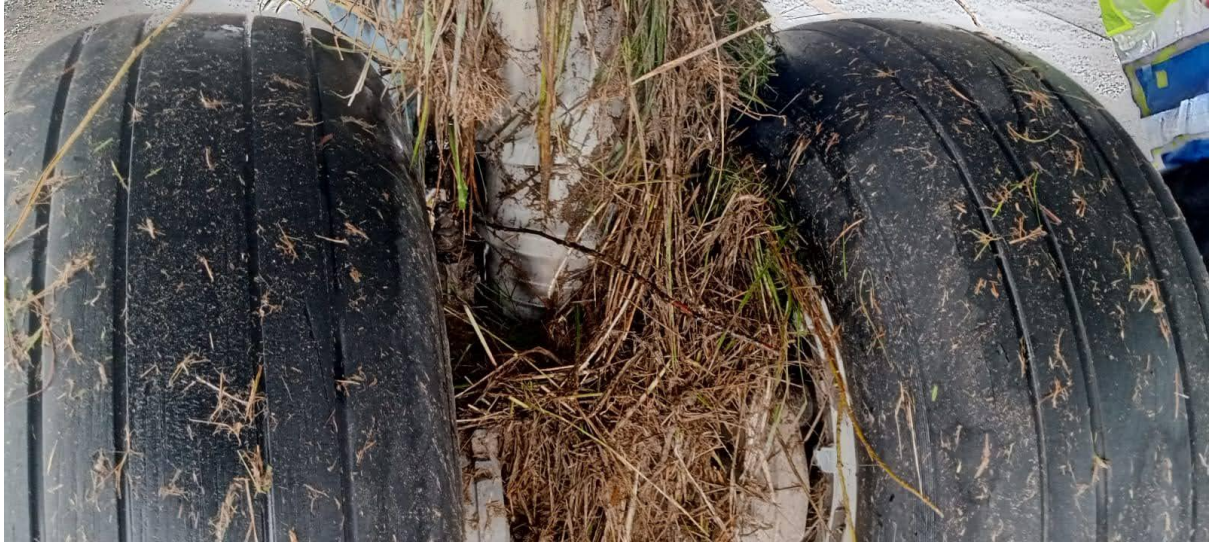
Figure 11. Debris on left main landing gear strut

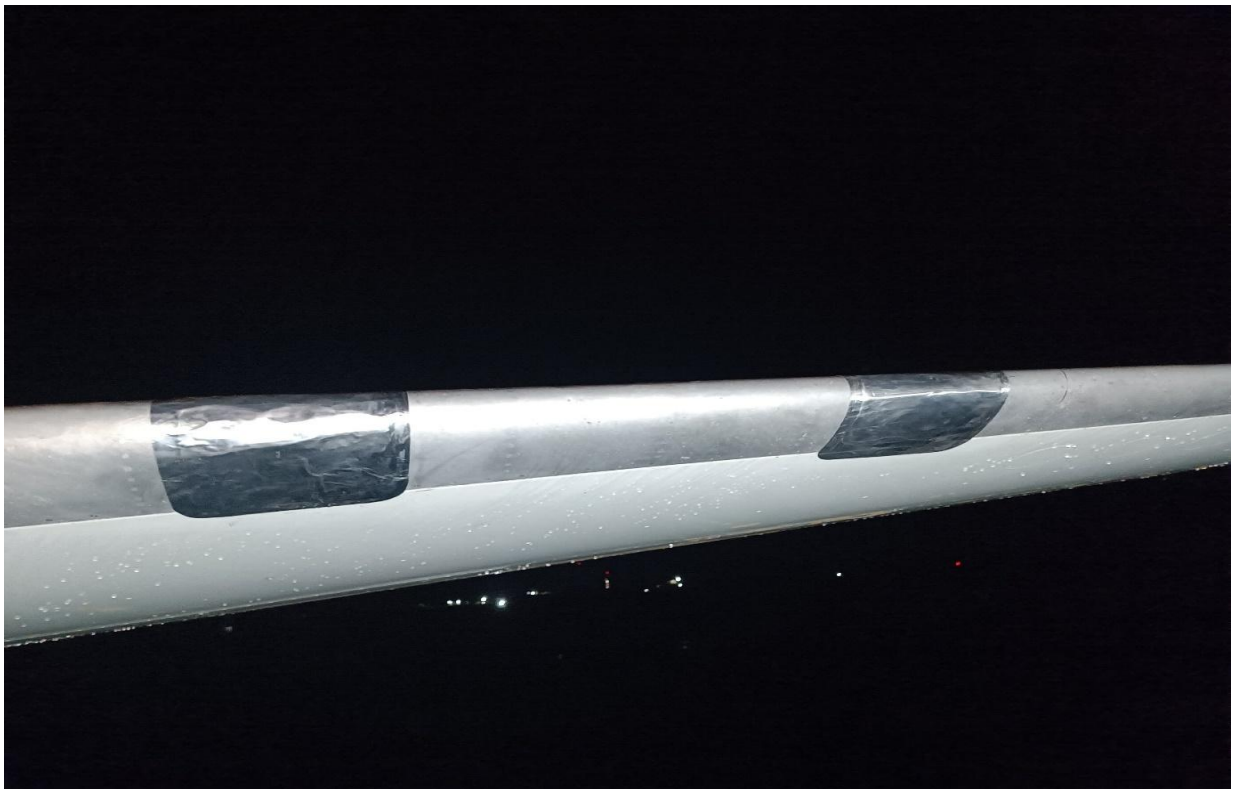
Figure 12. Speed tape on the dent mark of the left-hand horizontal stabilizer leading edge skin

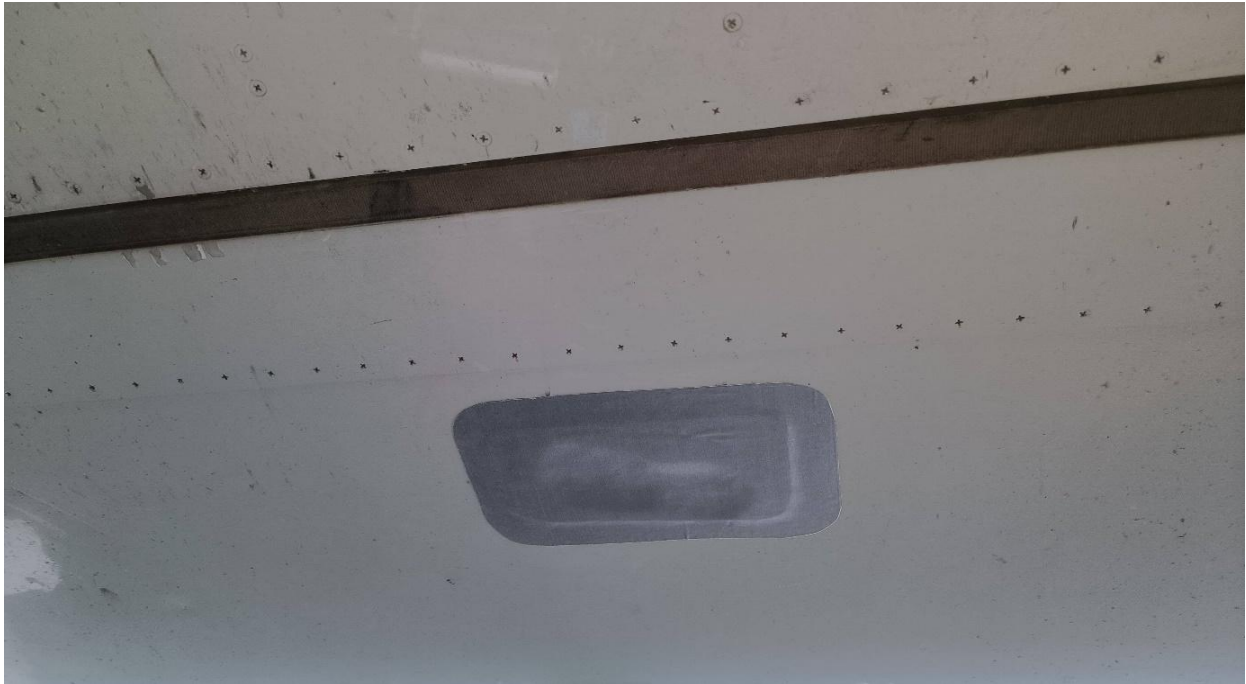
Figure 13. Crack to left hand wing inboard aft flap lower skin covered by speed tape

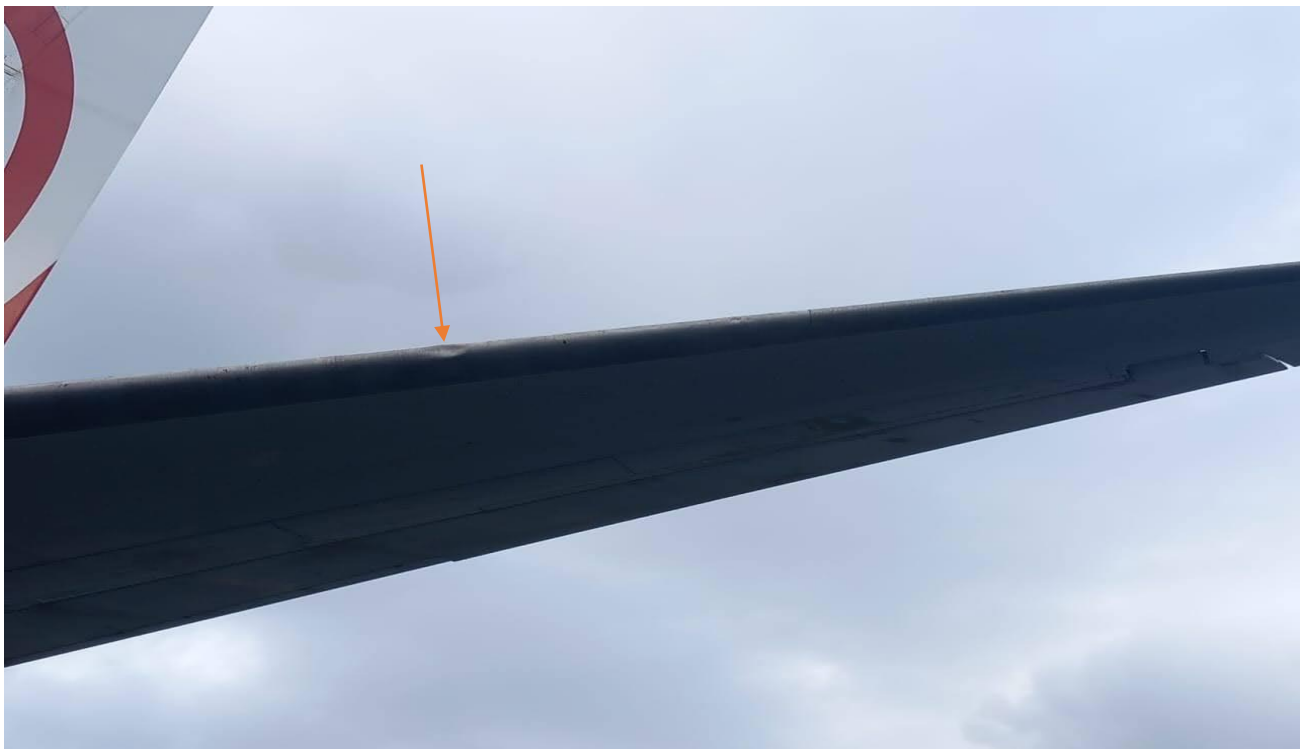
Figure 14. Dent created on the left-hand horizontal stabilizer leading edge skin

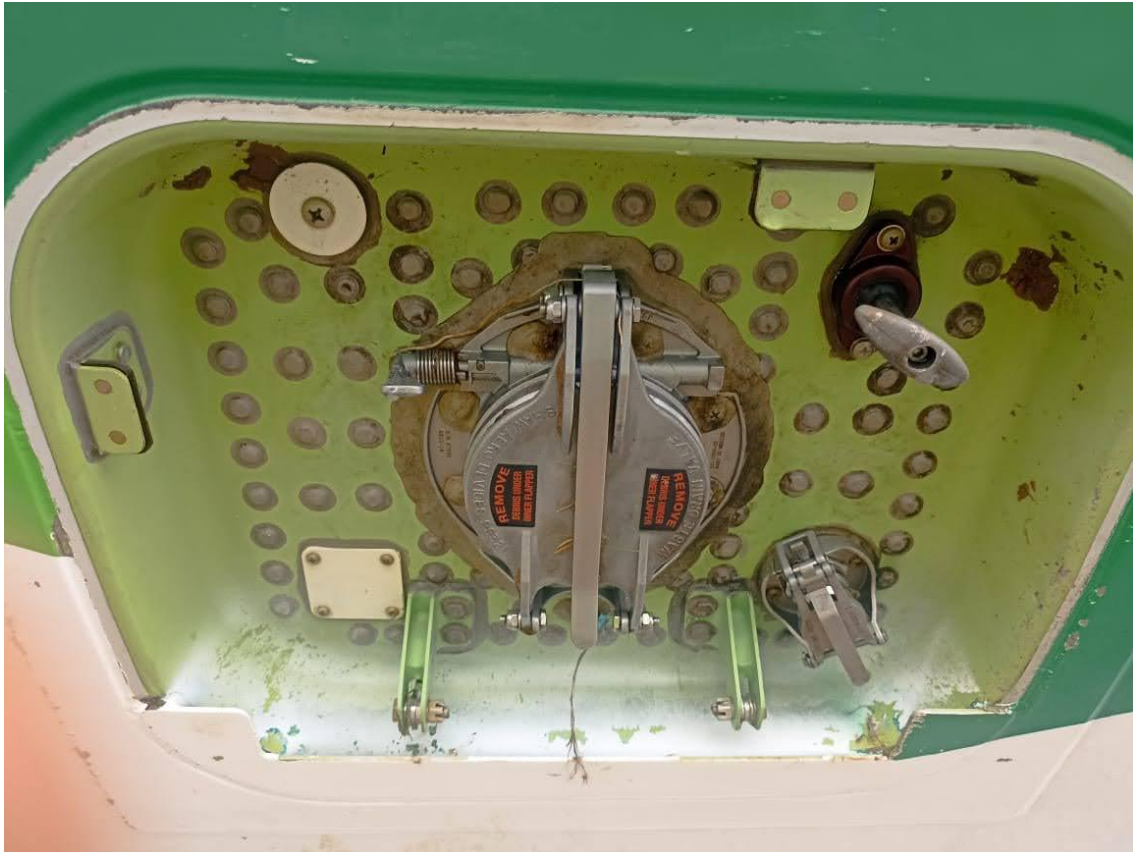
Figure 15. Lavatory service panel without cover

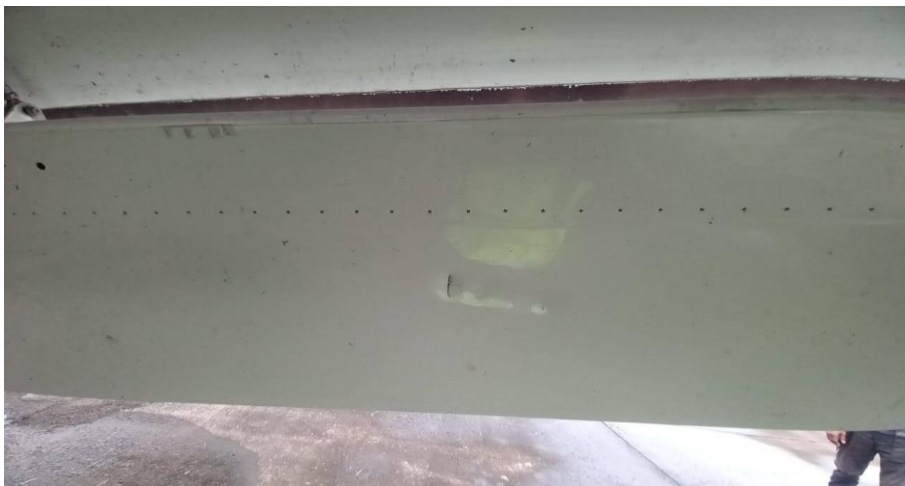
Figure 16. Dent with crack to the AFT flap lower skin
