**REPUBLIC OF LIBERIA**  
Aircraft Accident Investigation Bureau

# **PRELIMINARY REPORT**

ON SERIOUS INCIDENT INVOLVING VMO AERO NIGERIA LTD  
GULFSTREAM IV AIRCRAFT WITH REGISTRATION N770KS WHICH  
OCCURRED AT ROBERTS INTERNATIONAL AIRPORT (GLRB), LIBERIA,  
ON MAY 29, 2025.

**PRELIMINARY REPORT ON THE SERIOUS INCIDENT INVOLVING A GULFSTREAM IV AIRCRAFT OWNED BY BEST AIRCRAFT DEALS, USA, AND OPERATED BY VMO AERO NIGERIA, LTD, WITH NATIONALITY AND REGISTRATION MARKS N770KS, WHICH OCCURRED AT ROBERTS INTERNATIONAL AIRPORT, LIBERIA, ON MAY 29, 2025.**

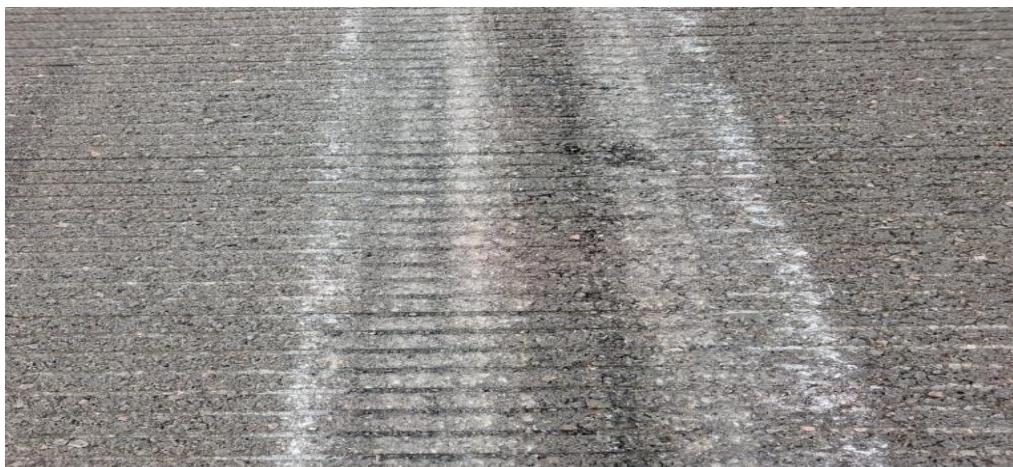
There were small craters, as shown in figure 2, caused by the deteriorating wheel assembly during the rollout phase of approximately 1 inch deep by 4 inches wide caused to the runway's surface at the location where the aircraft came to a stop. Additionally, referencing figure 1, there were skid marks on the runway resulting from the left main gear tire for 1322.9feet. The skid marks were created from R38 edge light (W 10° 21'34.4" / N 6° 14'17.7") to between L46 and L47 (W 10° 21'30.2" / N 6° 14'24.7") at which point the aircraft came to final rest.

**Figure 1: View of the skid mark on the runway created during the rollout phase by the left main gear wheel rims (#1 and #2)**

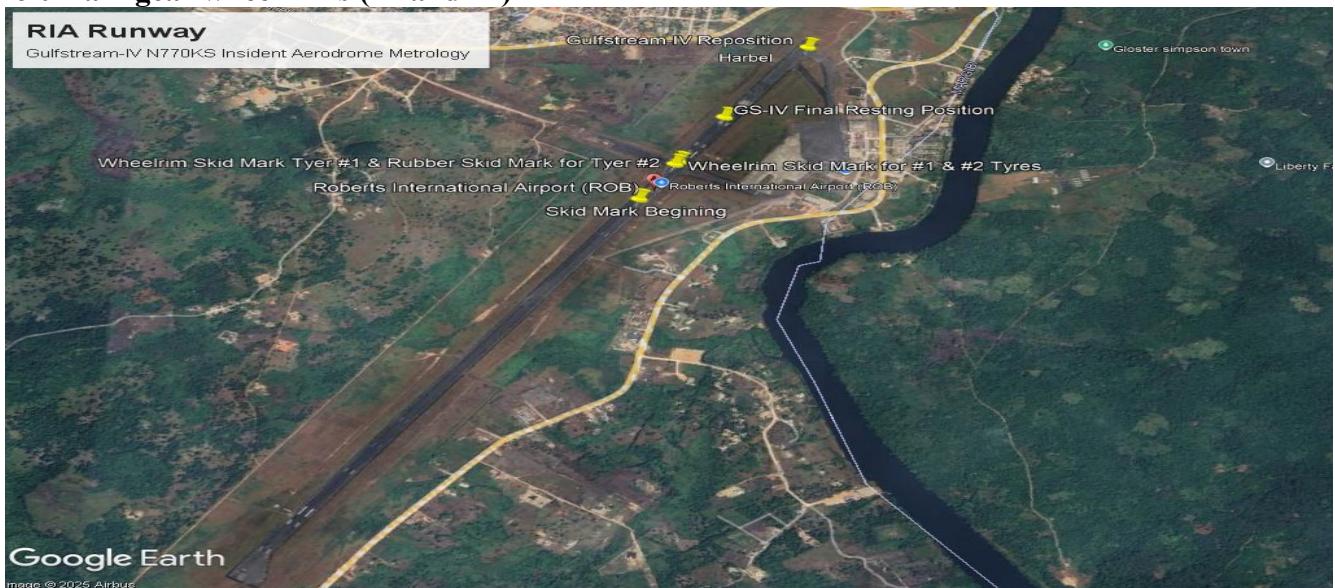
**Figure 2: View of the coordinates and distances of skid marks points, final resting position, and repositioned point.**

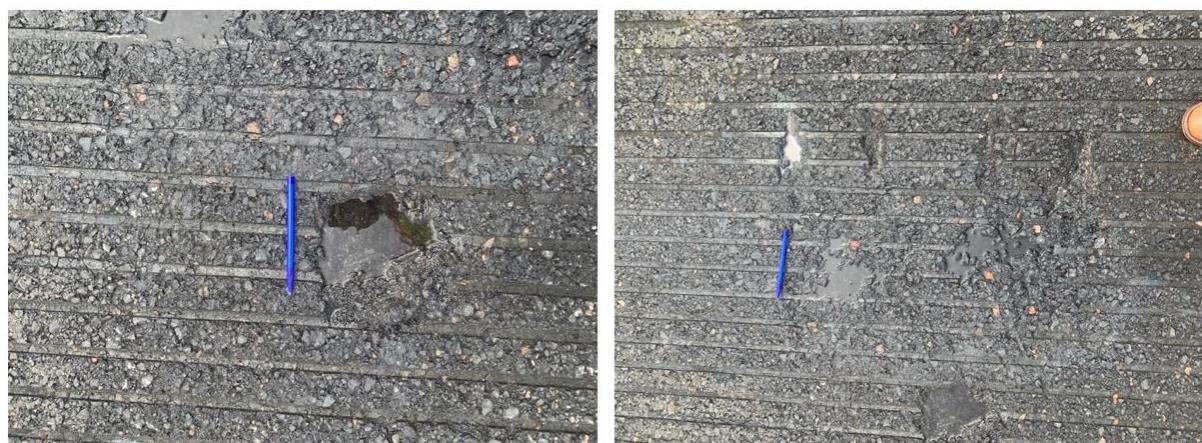
**Figure 3: Crater created on the runway where the left main gear came to rest**

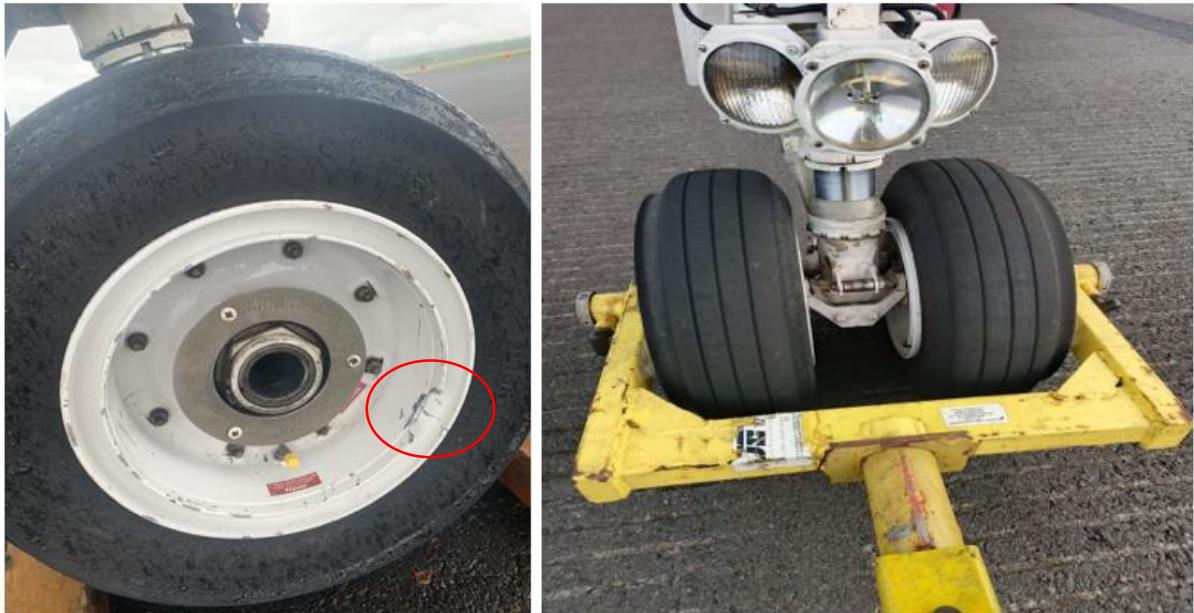
**Figure 4: Damage caused to the right nose wheel by the tow bar**

Post-occurrence damage revealed the outer flange of the right nose wheel rim exhibited localized gouging and paint removal caused during attempts to reposition the aircraft from the active runway. See figures below.

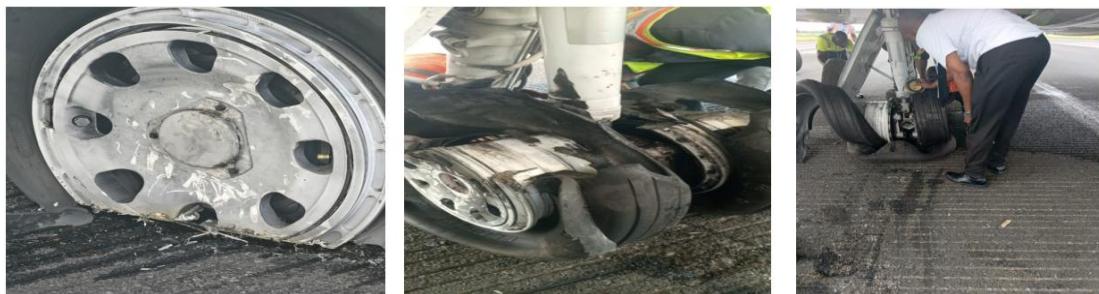
On May 29, 2025, at approximately 15:21 UTC, a Gulfstream IV aircraft operating under flight number LIB 001 experienced a dual tyre blowout on the left main landing gear during the landing rollout phase at Roberts International Airport. The aircraft came to a controlled stop on the runway centreline 2200 ft before the threshold at runway 22.

Figure 5: Left main landing gear initial damage post-occurrence

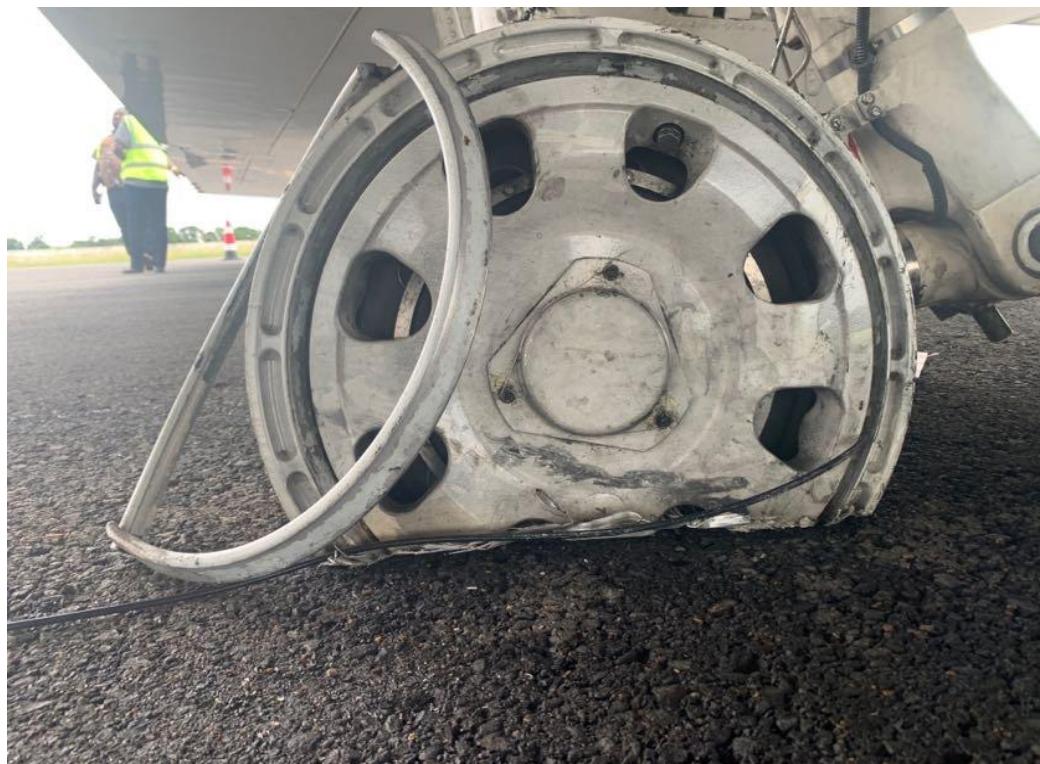
Figure 6: Secondary damage sustained as a result of removal of disabled aircraft

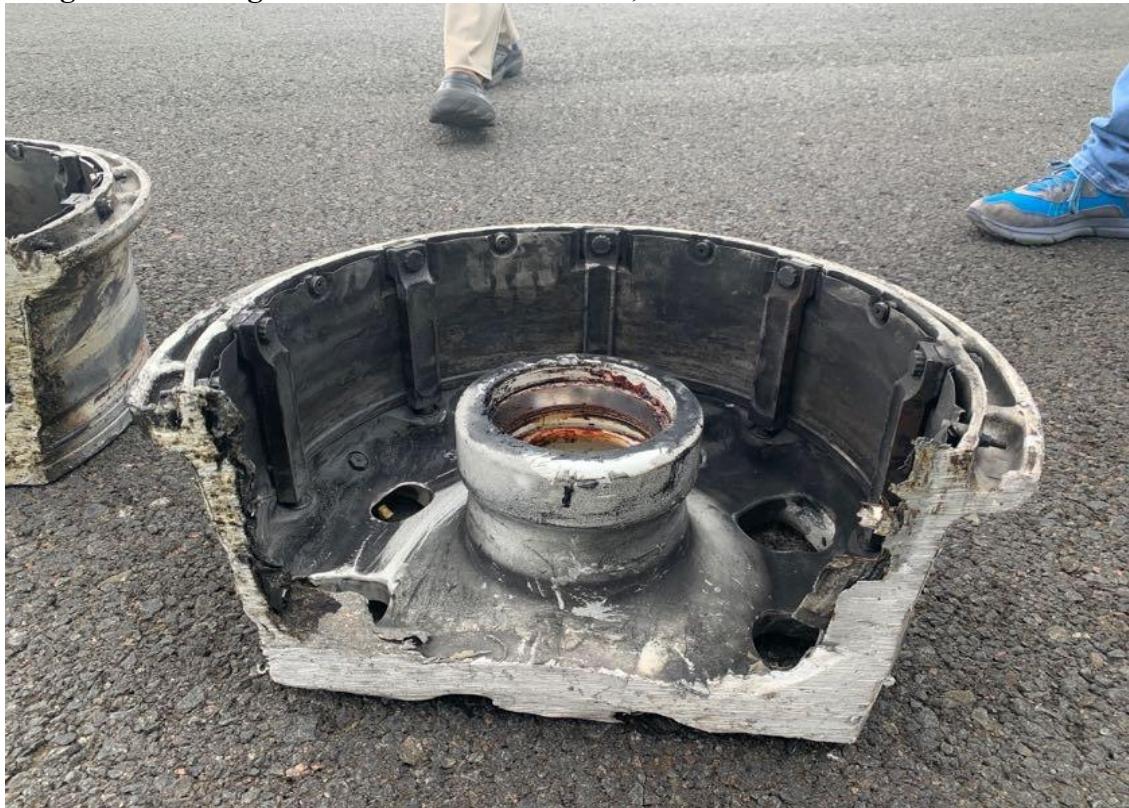
**Image 2: A view of the deformed wheel**

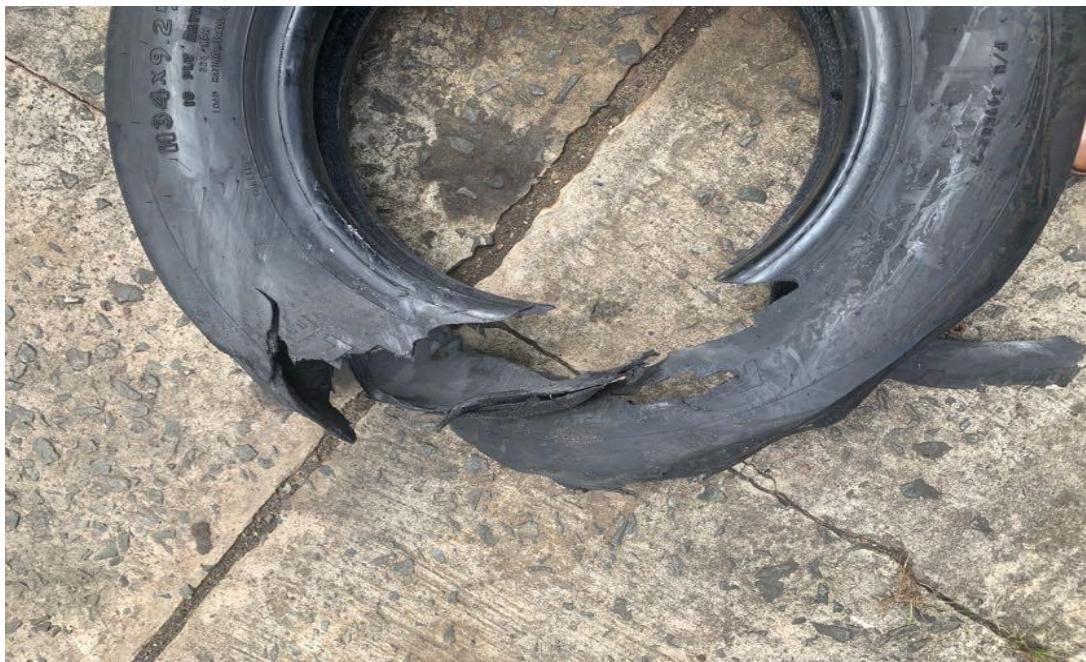
**Image 3: A view of the deformed tyre.**

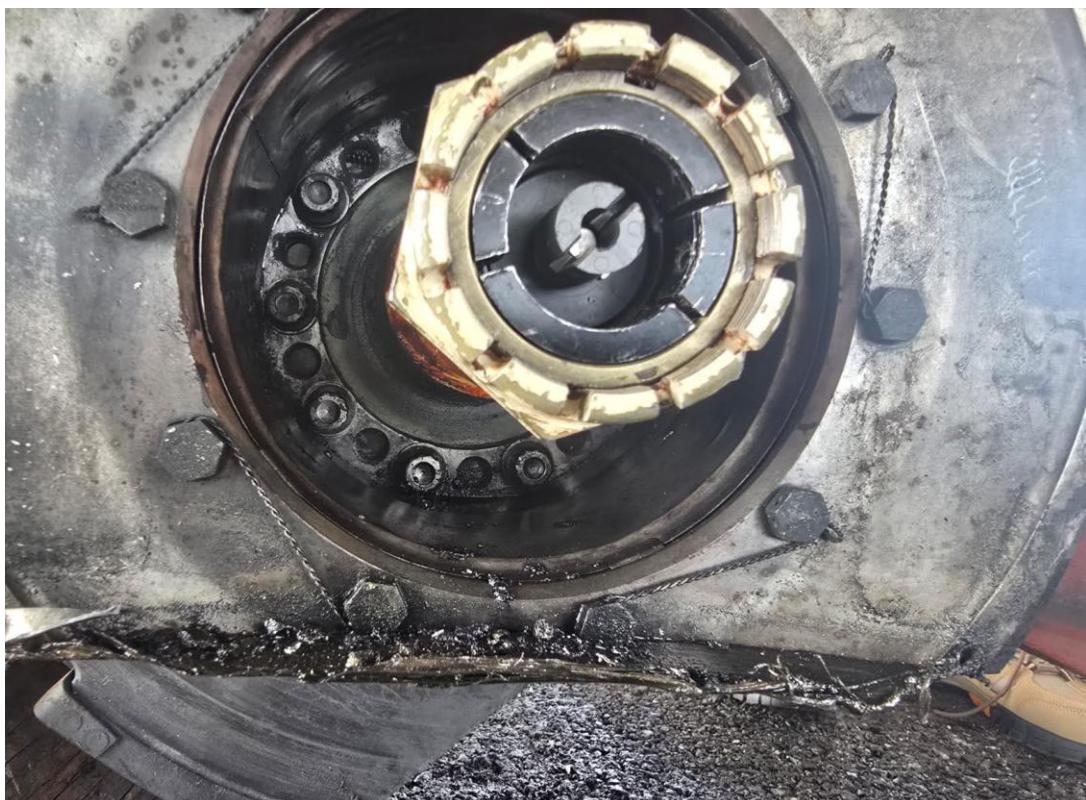
**Image 4: View of the ant-skid unit prior to replacement**

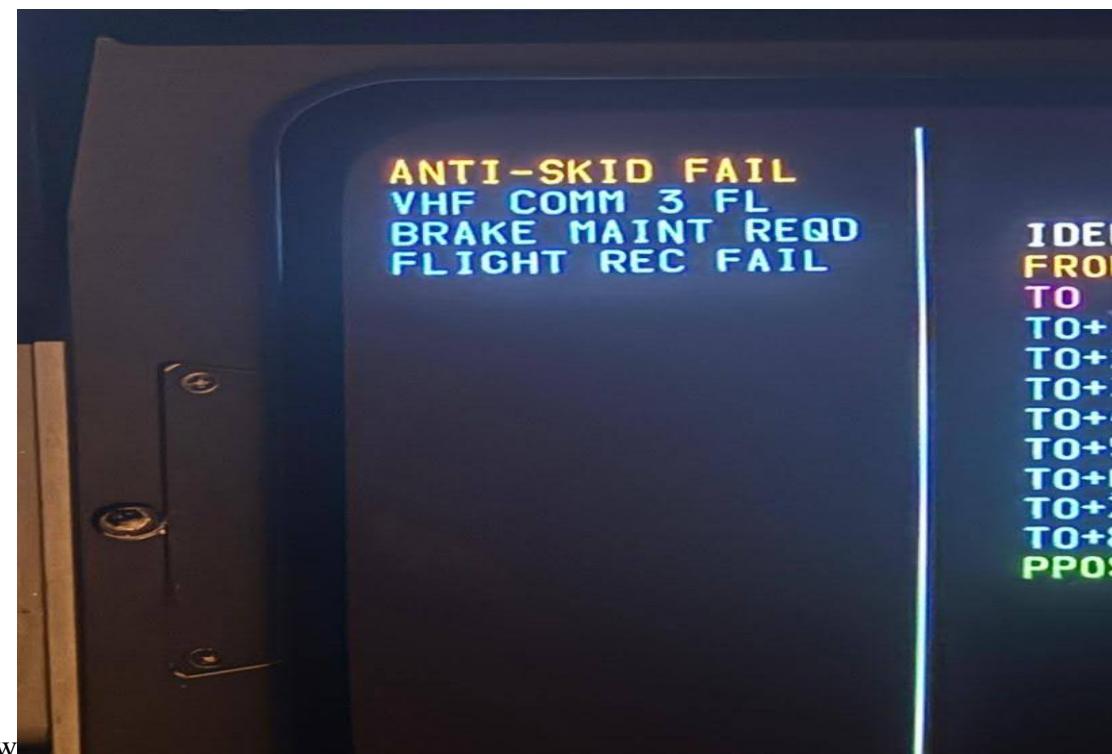
Image 6: Annunciator panel highlighting anti-skid fail in amber

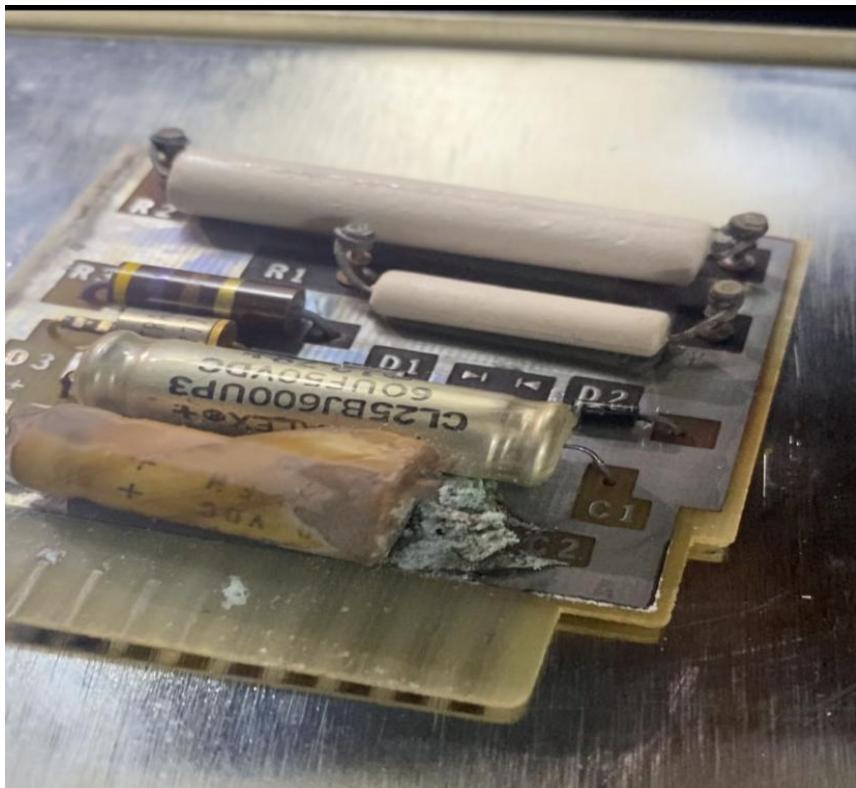
Upon inspection of the CVR it was observed to have visual signs of wear on the inside with traces of corrosion on the power supply chip.

7. Both recorders were retrieved from the aircraft but no data was found in them.
8. Upon inspection of the CVR carried on by the NSIB laboratory, it was observed to have visual signs of wear on the inside with traces of corrosion on the power supply chip.

**Image 7: Corroded Power supply chip of the CVR after retrieval**

The AAIB recommend that the GS-IV CVR and FDR be repaired or/and replaced before return to service for regular operations and reflected in the aircraft technical logbook.

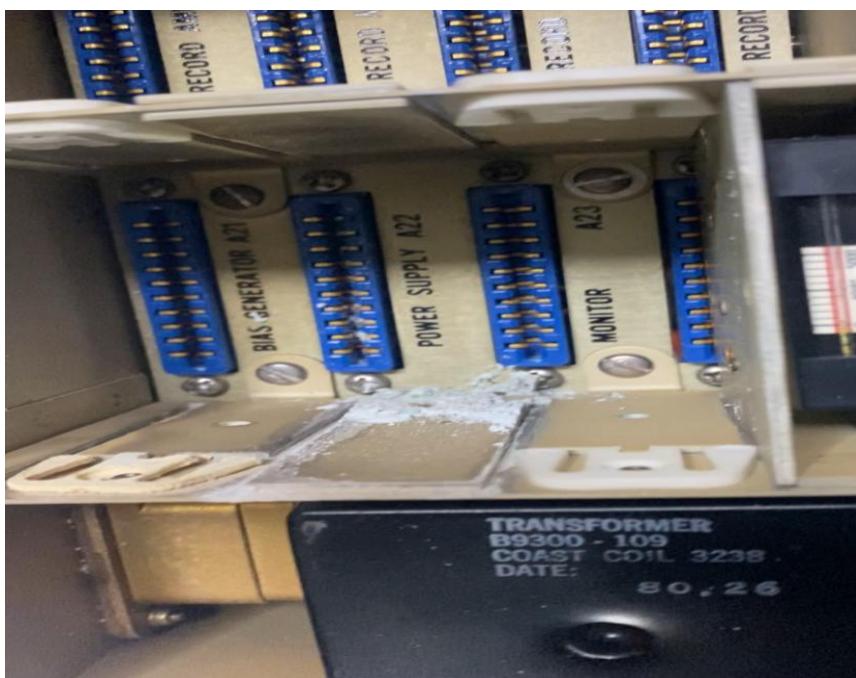
**Image 8: Signs of Corrosion in the chip housing**
