**REPUBLIC OF LIBERIA**  
Aircraft Accident Investigation Bureau

# **PRELIMINARY REPORT**

ON SERIOUS INCIDENT INVOLVING VMO AERO NIGERIA LTD  
GULFSTREAM IV AIRCRAFT WITH REGISTRATION N770KS WHICH  
OCCURRED AT ROBERTS INTERNATIONAL AIRPORT (GLRB), LIBERIA,  
ON MAY 29, 2025.

**PRELIMINARY REPORT ON THE SERIOUS INCIDENT INVOLVING A GULFSTREAM IV AIRCRAFT OWNED BY BEST AIRCRAFT DEALS, USA, AND OPERATED BY VMO AERO NIGERIA, LTD, WITH NATIONALITY AND REGISTRATION MARKS N770KS, WHICH OCCURRED AT ROBERTS INTERNATIONAL AIRPORT, LIBERIA, ON MAY 29, 2025.**

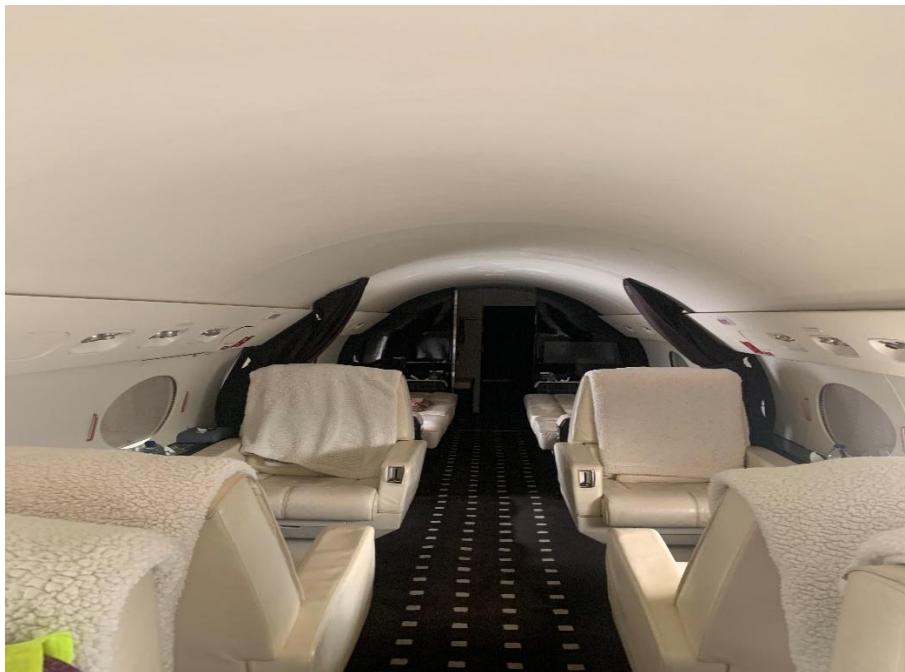
**Figure 7: Image of the cabin, post-occurrence**

The occurrence was survivable in that the passenger restraint system (seat belts and shoulder harnesses) was intact, and there was liveable volume for the occupants. The crew and passengers disembarked unhurt.

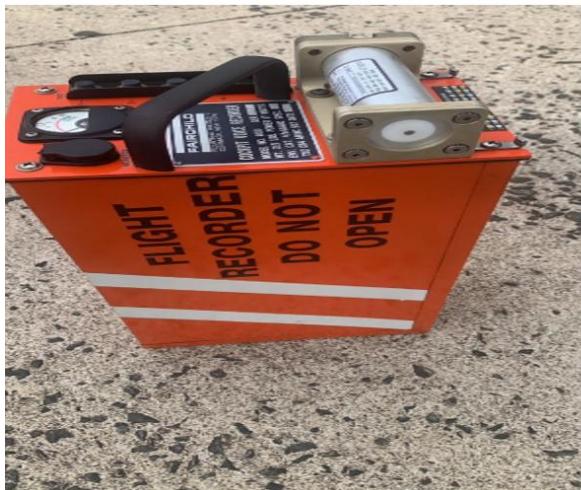
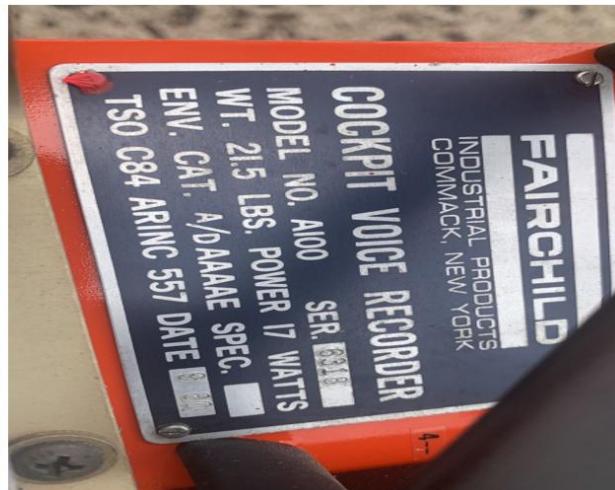
Image 9: Gulfstream IV N770KS, Cockpit Voice Recorder (CVR)

Upon inspection of the CVR it was observed to have visual signs of wear on the inside with traces of corrosion on the power supply chip.

7. Both recorders were retrieved from the aircraft but no data was found in them.
8. Upon inspection of the CVR carried on by the NSIB laboratory, it was observed to have visual signs of wear on the inside with traces of corrosion on the power supply chip.
